STRUCTURAL REPORT  
FOR  
**FORMER VETERANS MEMORIAL BUILDING**  
VALLEJO, CALIFORNIA

Prepared for

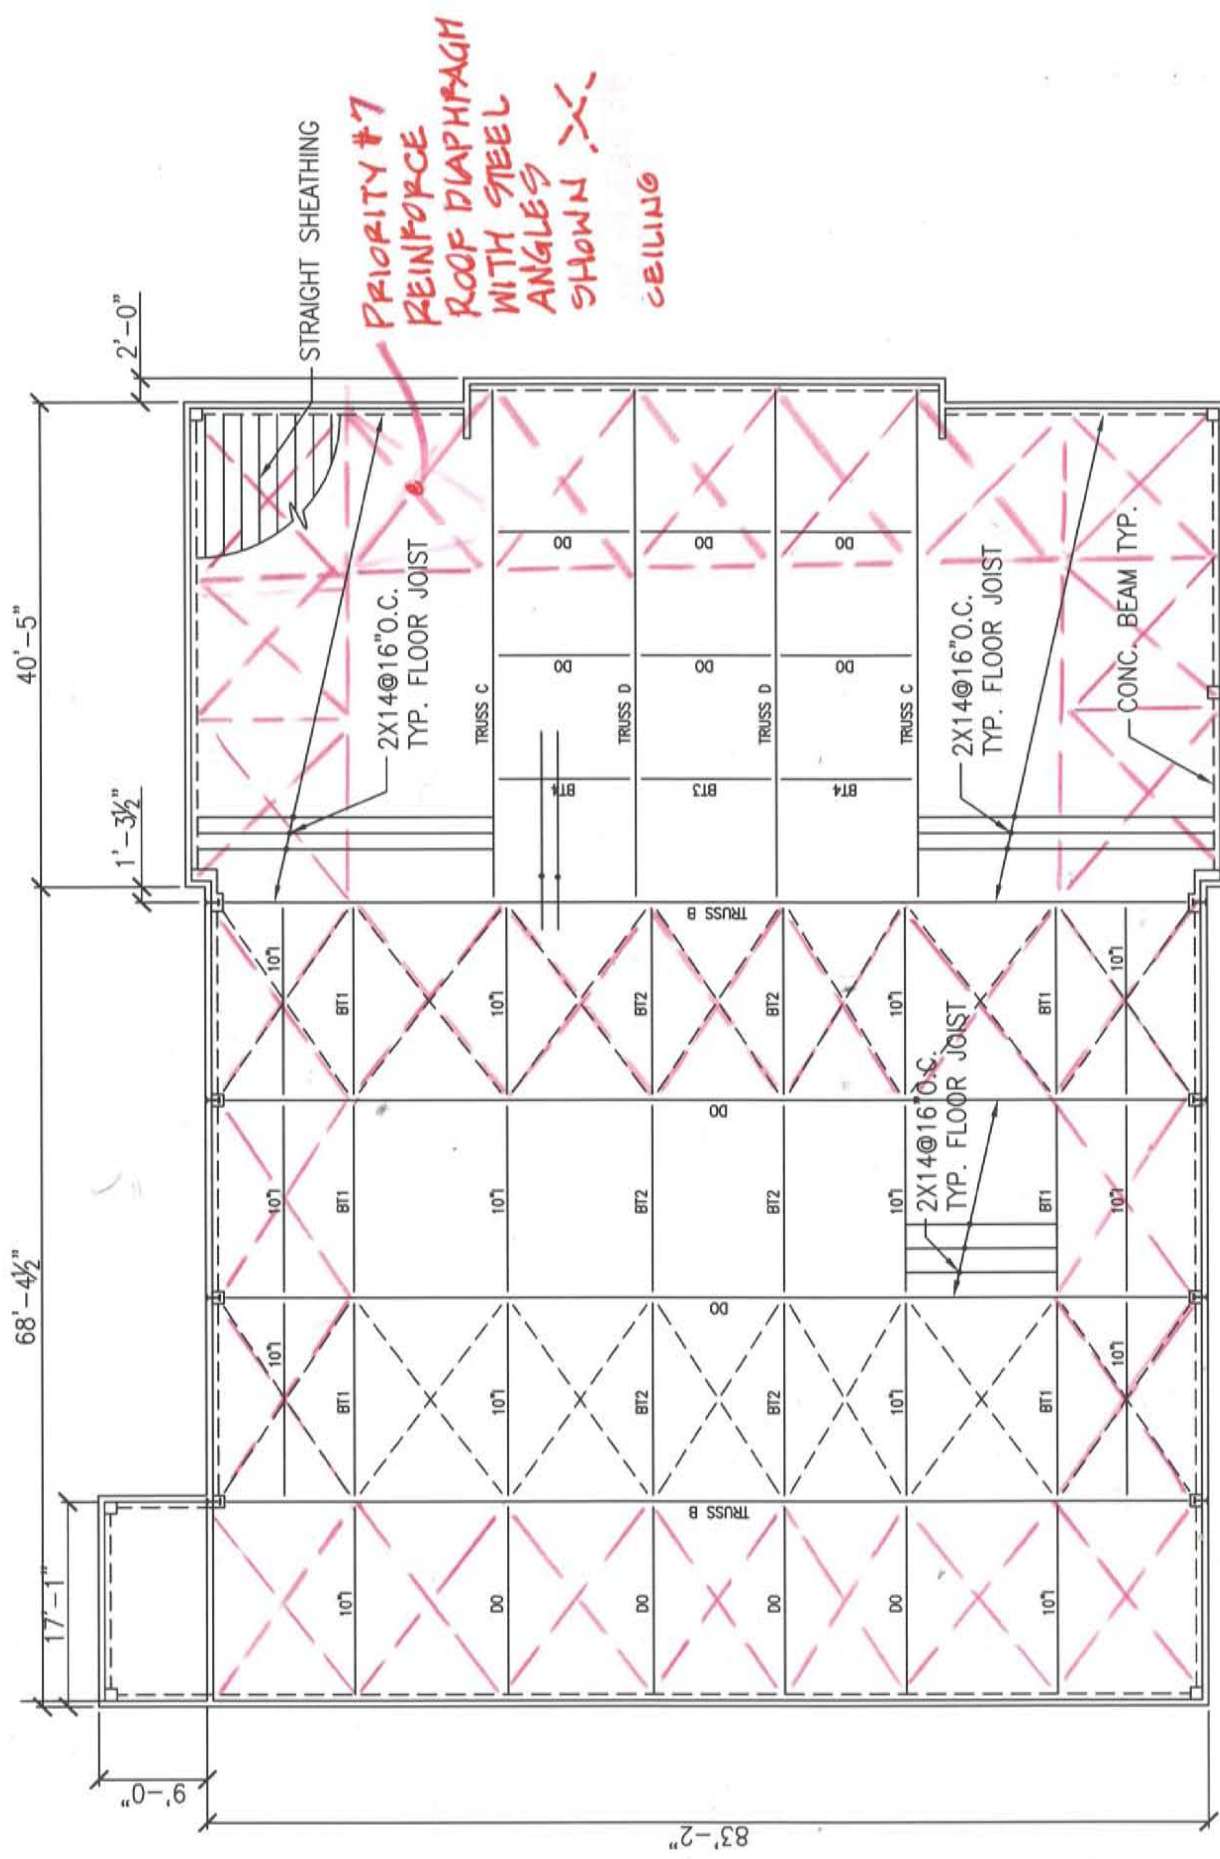
The services performed for this project have been provided at a level that is consistent with the general level of skill and care that is typically provided by engineers practicing Structural Engineering. Work completed is done under the constraints of time and budget. No warranty is expressed or implied.

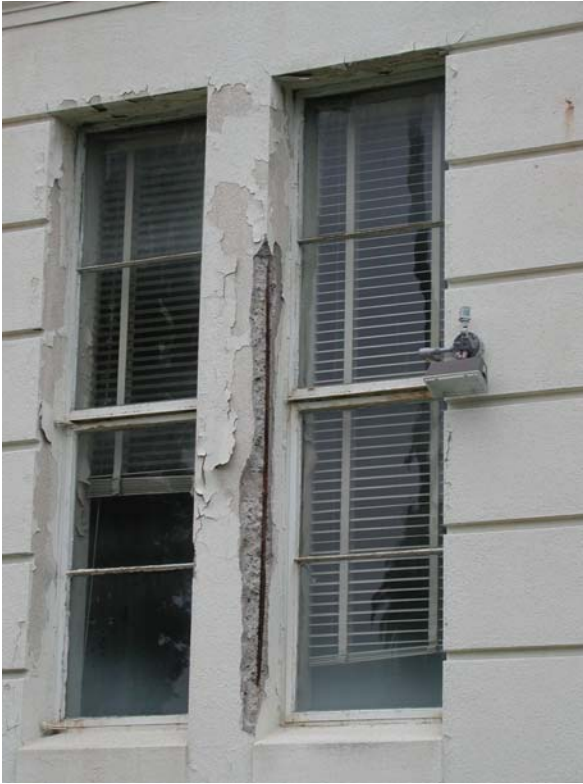
Concrete Spalling at Façade

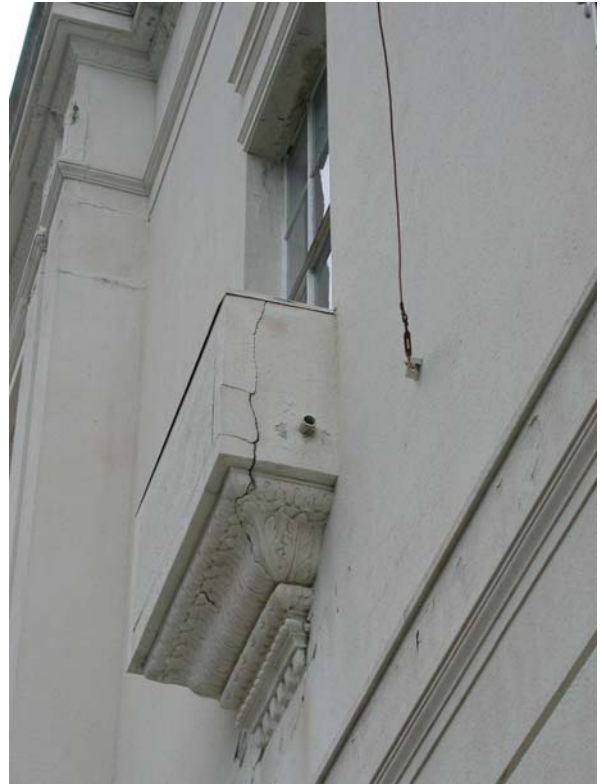
Cracking at Ornamentation

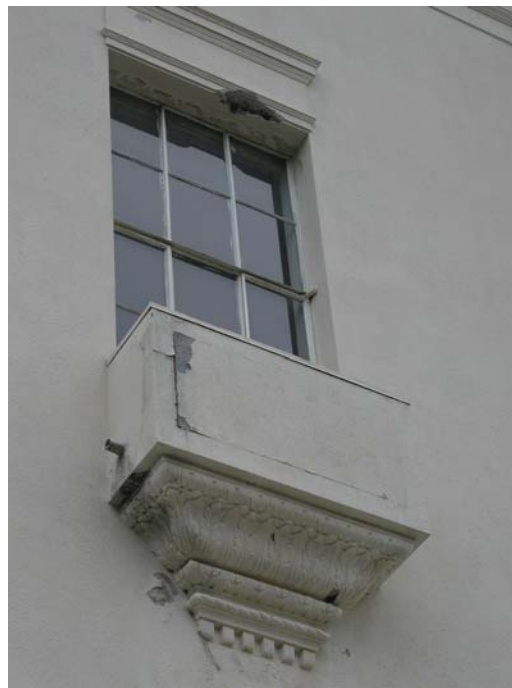
Concrete Spalling at Header  
(March 2008)

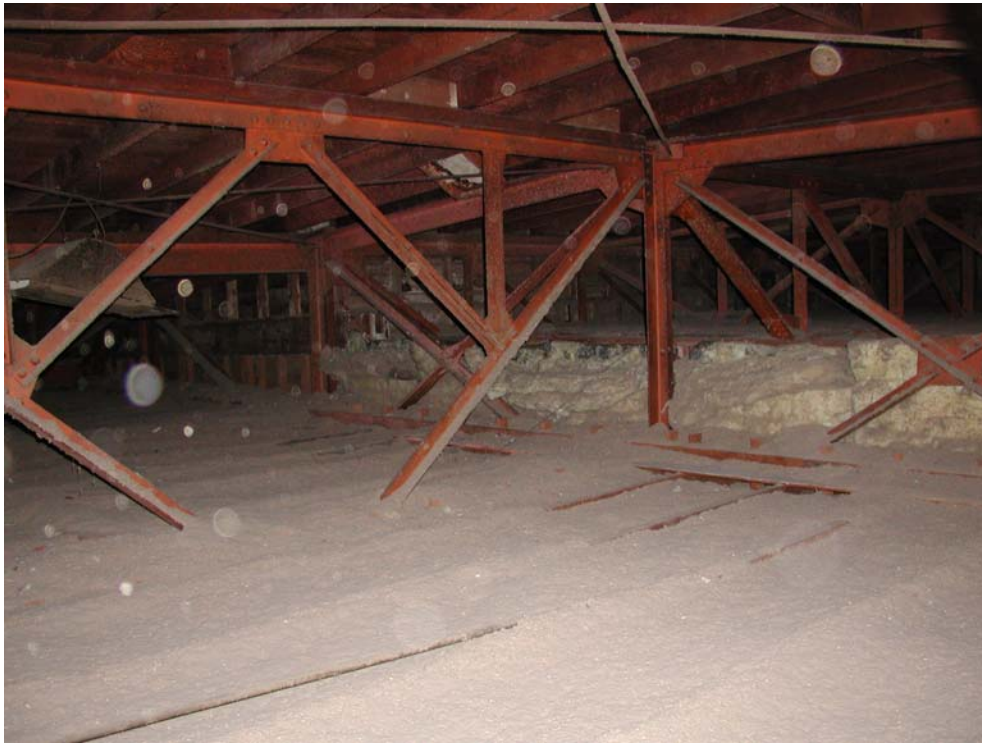
Roof trusses, wood rafters, straight sheathing and ceiling joists

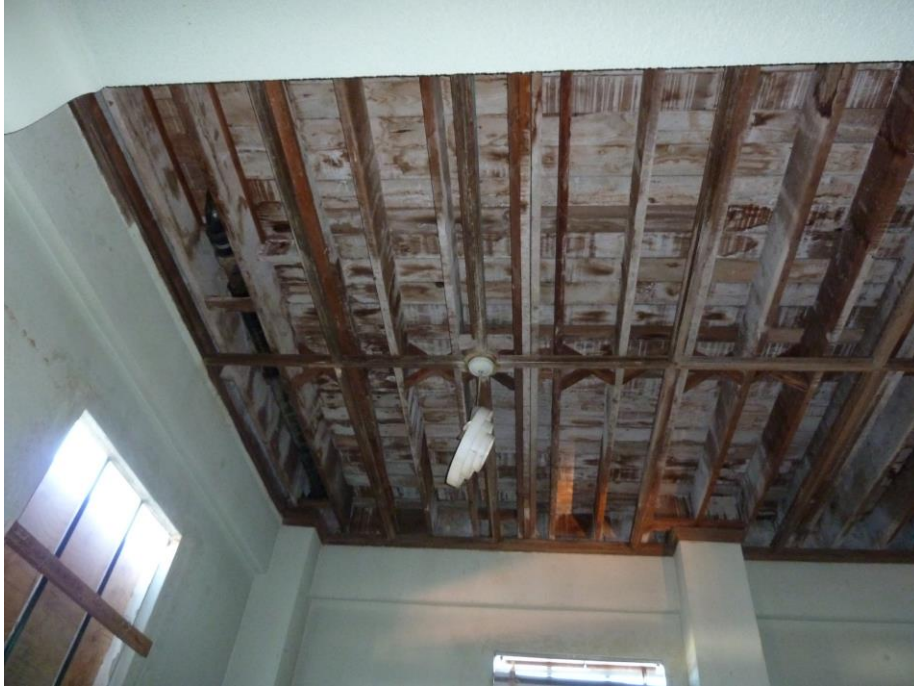
Water Damage at 2<sup>nd</sup> Floor

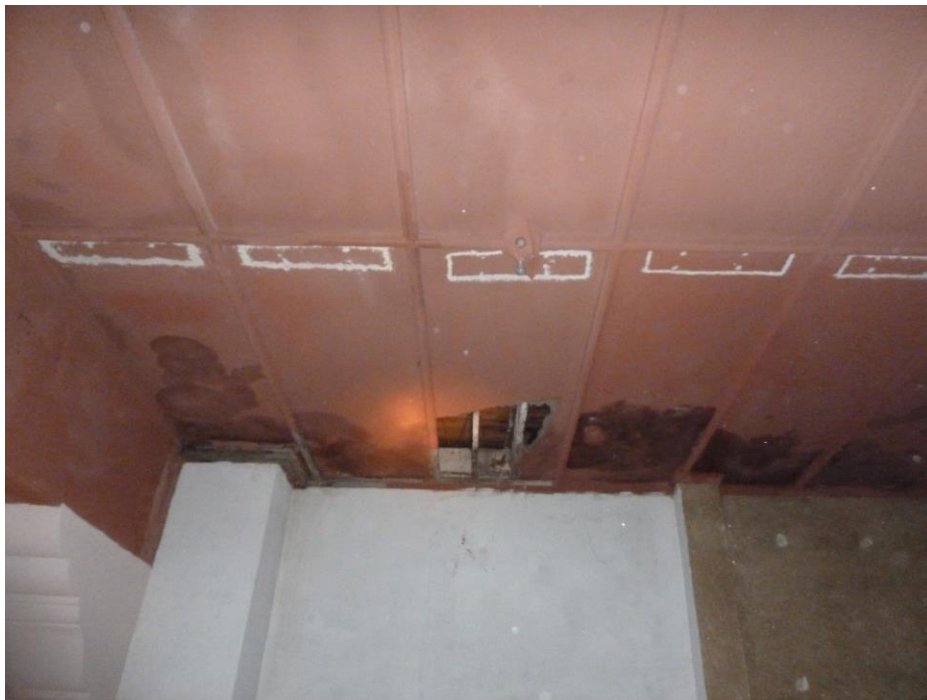
Water Damage at 2<sup>nd</sup> Floor

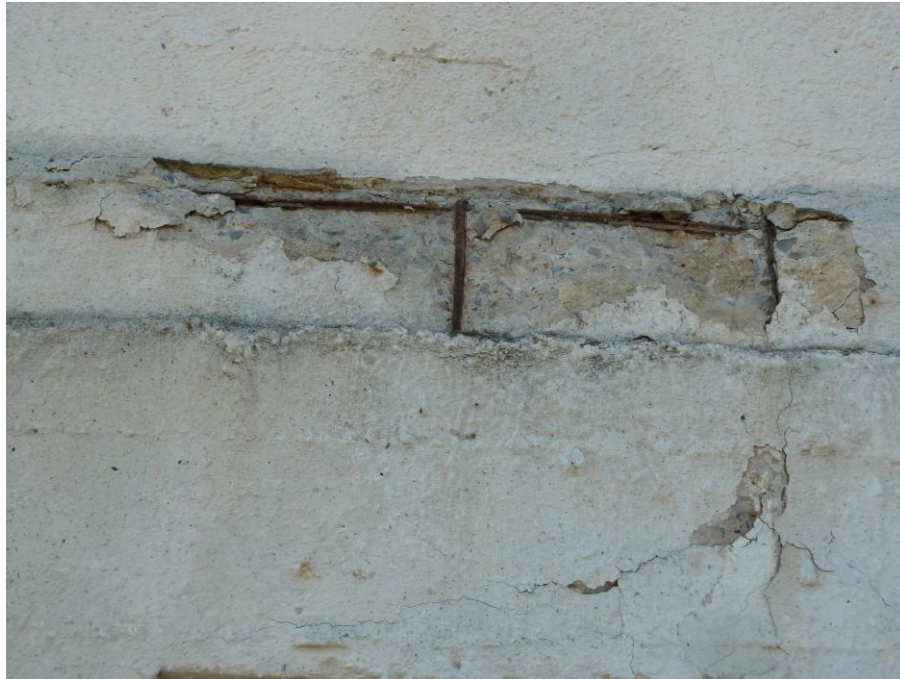
Exposed reinforcing on North Façade

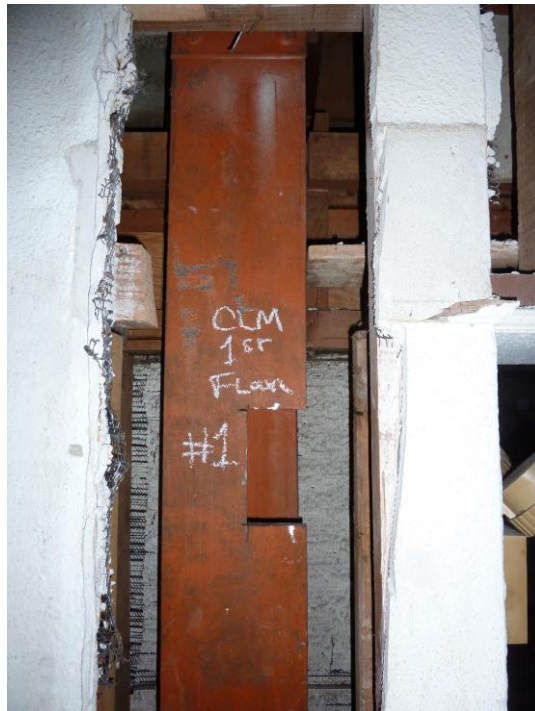
Column with coupon cut from flange  
(Repair required)

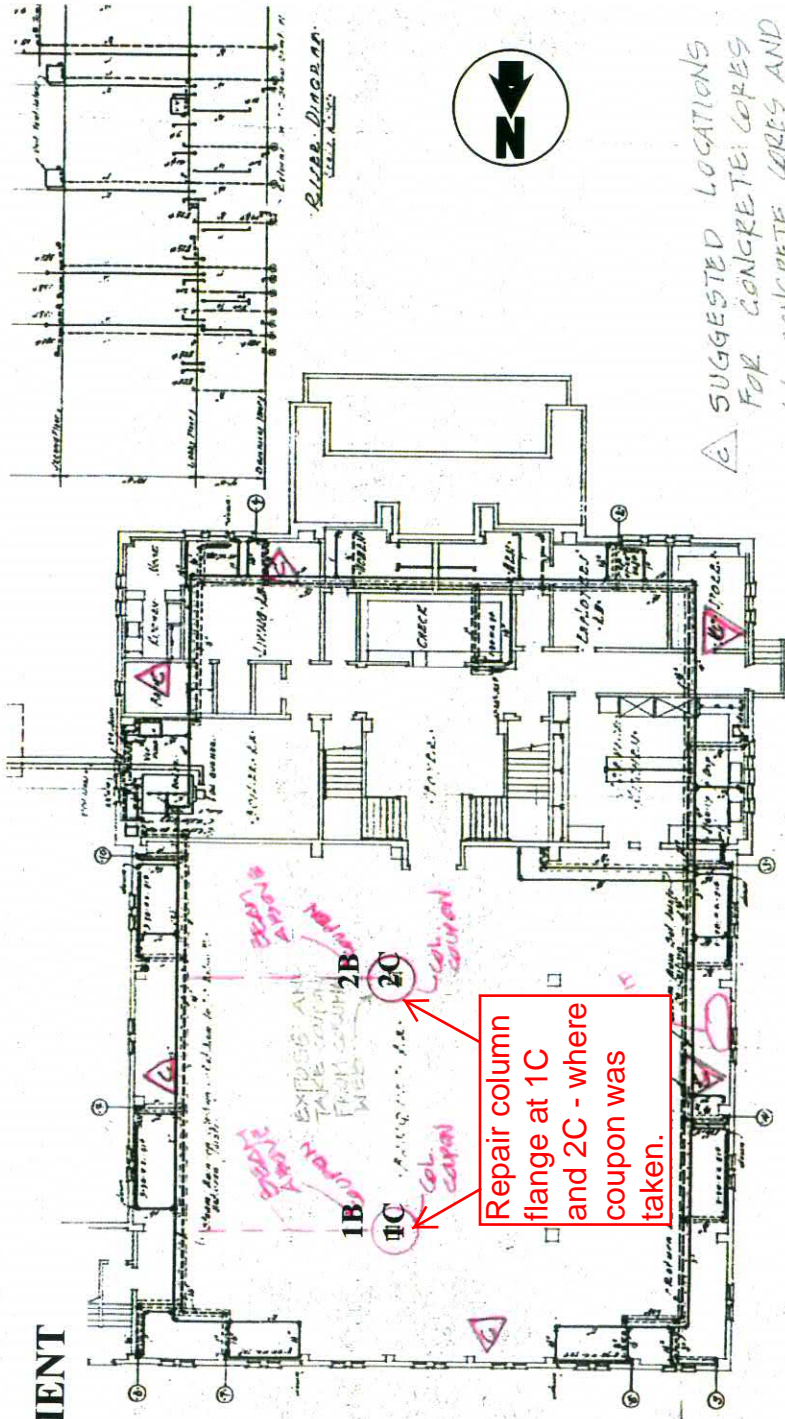
Repair column flange at 1C and 2C - where coupon was taken.
